USAAVLABS TECHNICAL REPORT 70-66

MODE OF FAILURE INVESTIGATIONS
OF HELICOPTER TRANSMISSIONS

January 1971

CONTRACT DAAJ02-69-C-0061
BELL HELICOPTER COMPANY
FORT WORTH, TEXAS

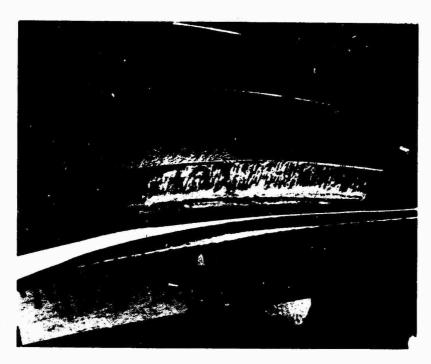
Figure 36. Scored Teeth on Input Pinion (P/N 204-040-700-1).

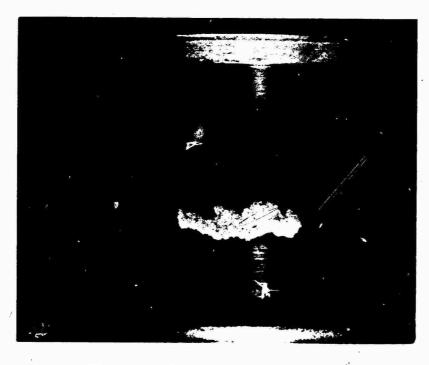
Figure 37. Spalled Roller Bearing Surface on Input Pinion (P/N 204-040-700-1).

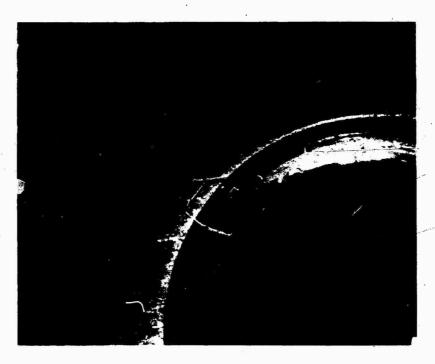
Figure 39. Close-Up of Crack on Input Bevel Gear (P/N 204-040-701-3).

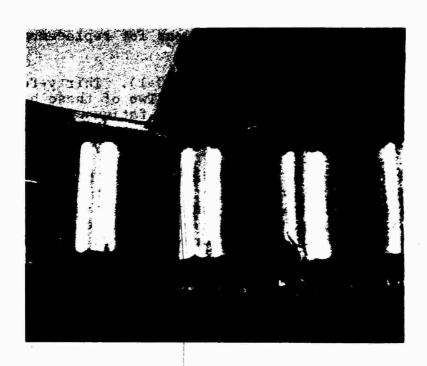
Figure 42. Broken Sprag in Freewheeling Clutch (P/N X-131720).

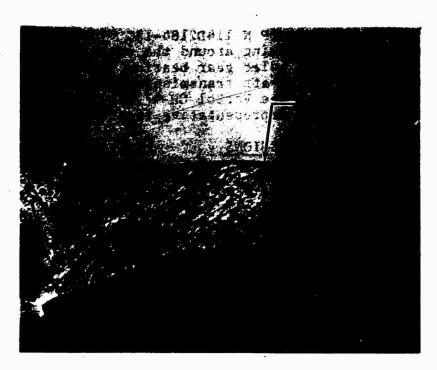
Figure 50. Fracture Face of Cracked Support Assembly (P/N 114D1088-14).

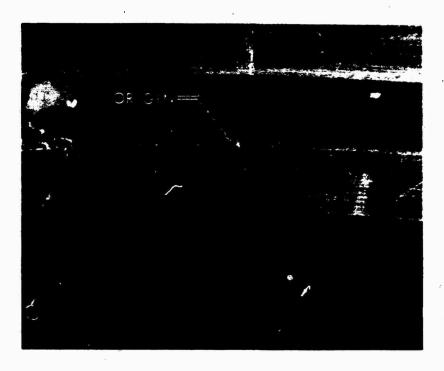
Figure 51. Cracked Support Assembly (P/N 114D1088-14).

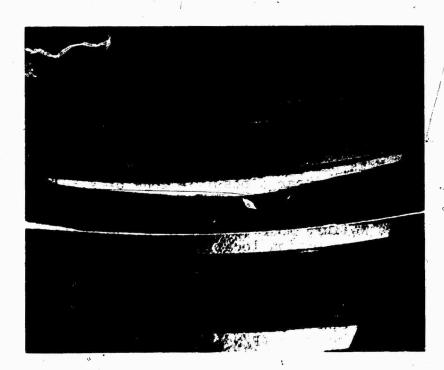
Item No. 16A - Pinion, and 17A - Gear (P/N's 114DS2045-5 and 114D2062-1). Two pinions and three gears were replaced because of pitting on the gear teeth (Figures 64 and 65). The heavy wear in the flank of the pinion tooth and along the addendum of the gear tooth resulted from the pinion moving out of mesh. The normal gear pattern may be seen as the lightly worn area above the pitting in Figure 64. Figures 66 and 67 show wear on the bearing journals of the pinion caused by bearings spinning. Figure 68 shows fretting and wear on the outer diameter of the input roller bearing, and Figures 69 and 70 show wear on the bearing inner ring and outer ring spacers. Items 28A and 25A (P/N's 114D2191-2 and 114D2145-1). This wear on pinion, bearings, and spacers permitted the pinion to move out of mesh, resulting in inferior tooth bearing contact, which produced contact stresses sufficiently high to induce pitting of the gear teeth. One gear had spots on the faces of several teeth that appeared to be frosting or scuffing (Figure 71). The outline of these areas was faintly visible on teeth of the mating pinion. Wear on the teeth outside of these areas appears to be normal, except that there is evidence of improper pinion location or shimming, i.e., the high and back pattern location shown in Figure 71. Surface finish on the pinion teeth and in nonfrosted areas of the gear teeth is satisfactory. A cross section through a frosted area showed the depth of affected material to be less than .0002 inch (Figure 72). Surface hardness was Rc62.8 and core hardness was Rc41.0 (drawing requirements are Rc60-64 and Rc36-40, respectively). No abnormalities in microstructure were found. There was evidence of debris damage to other gear meshes and bearings in the transmission by ingestion of entrapped particles. One bearing in this transmission was found to have a spalled roller, but the failure was in early stages with only small particles missing. It is considered improbable that the spots of surface distress on the teeth of the gear were caused by debris particles going through gear mesh. Since the distress occurs near a possible zone of single tooth contact, as evidenced by the short face contact, and bears distinct family resemblance to scuffing, it is concluded that this isolated failure mode is that of a lubrication failure. Since the improper pinion location may have been partially due to the customary bearing and spacer wear, which would have occurred during the 596 hours this part operated, this failure has been classified as secondary.

Figure 65. Pitting in Addendum of Spiral Bevel Gear Teeth (P/N 114D2062-1).

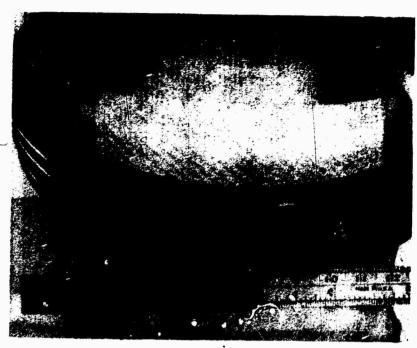
Figure 70. Wear on Face of Lubricator (Bearing Outer Ring Spacer) (P/N 114D2145-1).

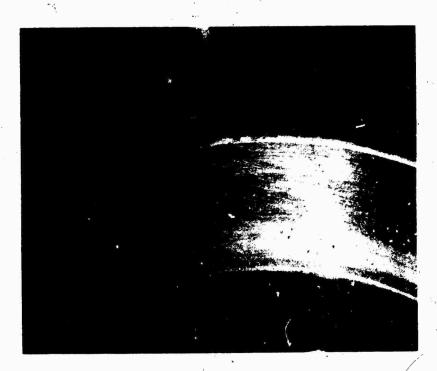
Figure 78. Close-Up of Wear and Cracking on Retainer (P/N 114D2184).

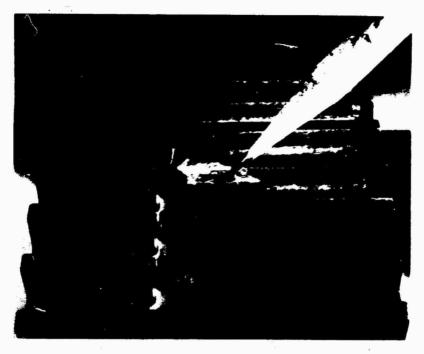
Figure 84. Chipped Tooth on Upper Sun Gear (P/N 204-049-330-3).

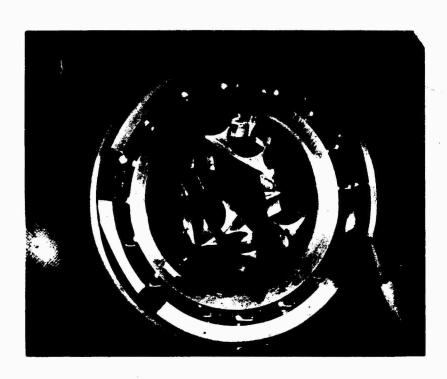
Figure 86. Failed Bearing Retainer (P/N 204-040-346-3).

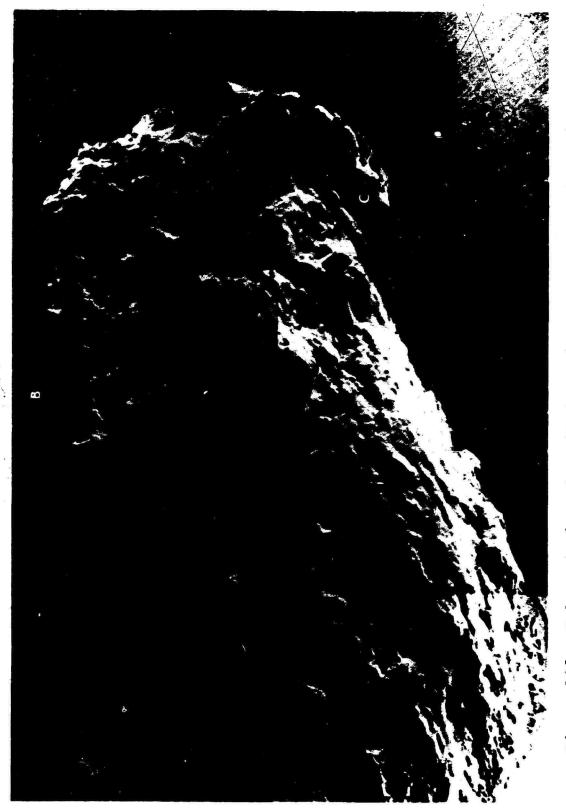
The entire spalled area was carefully examined, and those areas labeled "A" and "B" in Figure 103 were considered representative of the basic spalling propagation mechanism that was observed. Area "A" is shown at higher magnification in Figures 104 and 105, and shows the propagation of the spalling by the formation of a small flat chip at the edge of the spalled region. The chips evidently were formed by the propagation of a subsurface crack and then fractured away from the parent material by the formation of secondary cracks between the subsurface crack and the surface of the bearing race. The subsurface crack could have been hydraulically propagated. Fine striations may be seen in Figures 104 and 105, running approximately parallel to the rolling direction of the race. Although the origin of the striations can only be speculated upon, they are most likely formed by the relative movement between the chips and the substrate. It should have been possible to determine the origin by finding the converging point of the

Figure 103. Enlarged View of Spalled Bearing Outer Race (P/N 114DS143-1) Magnification 50X.

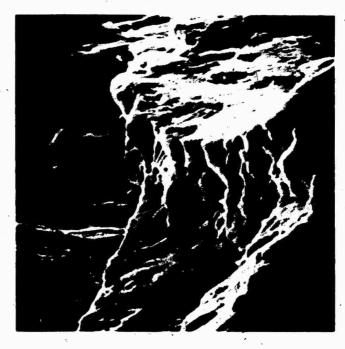
striations, but the debris damage to the central portion of the spalled area, from balls rolling over entrapped particles, makes this impossible. Figures 106 and 107 show a subsurface crack in area "A" located nearly parallel to the surface of the race. The spalling failure is suspected to have been the result of surface damage of undetermined origin.

Figure 106. Enlarged View of Area B (P/N 114DS143-1).
Nagnification 500X

Figure 107. Enlarged View of Area B (P/N 114DS143-1).
Magnification 2000X

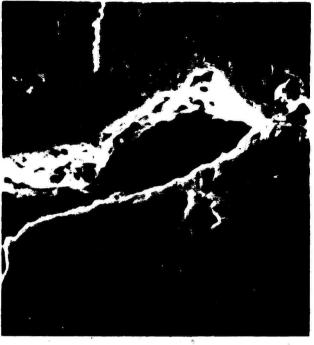
The segment of the crack labeled area "a" in Figure 110 is shown at higher magnifications in Figure 111. Figure 111 indicates that local crevices are formed at the intersection of branching cracks. This may have been the mechanism by which the spalled region was initiated. The surface of the crack is shown more clearly on the right. It appears to have a crystalline appearance similar to that of the vertical secondary cracks in the first bearing specimen. No evidence of massive inclusions was found along this crack; however, evidence of a cluster of inclusions was found in area "b" of Figure 110 and this is shown in Figure 112. These inclusions apparently provided a preferential fracture path in this area. Inclusions of this nature could be associated with either a lap or an inclusion pocket, and this could have been the primary contributing factor to the initiation of the spalling failure.

Enlarged View of Area A (P/H 114DS242-1). Figure 111.

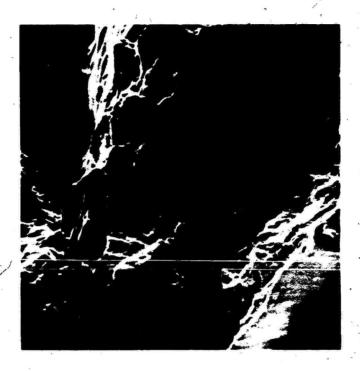
Area "c" in Figure 110, shown at a higher magnification in Figure 113, had an appearance similar to that of the crevice shown in Figure 111. This area also somewhat resembled an

Figure 115. Enlarged View of Area C (P/N 114DS242-1).

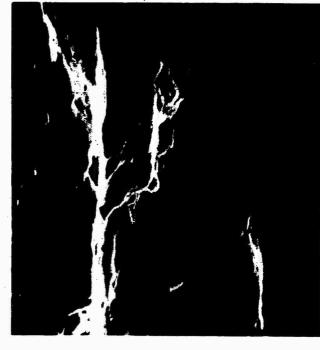
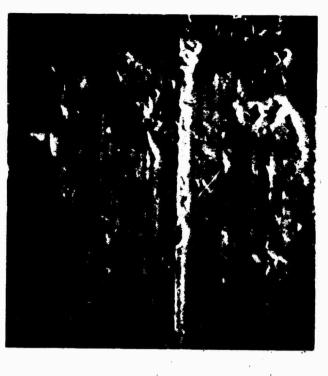
The general condition of the surface of the race adjacent to the spalled region can be seen in Figures 111 and 114. Figure 115 is from an area adjacent to the spalled region where the most severe surface damage was detected. There was surprisingly little evidence of crack formation in the damaged area as compared with the earlier specimen; this could indicate that this specimen may have been more resistant to crack formation than the earlier specimen.

Figure 115. Surface Damage Near the Spalled Region (F/N 114DS242-1).

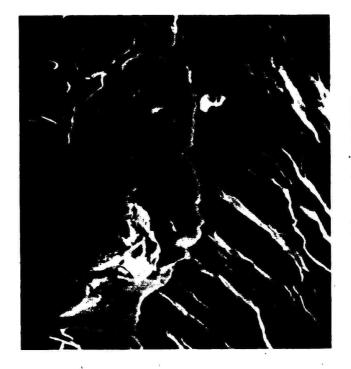
Figure 127. Enlarged Views of Area G (P/N 204-040-330-3).

Small individual spalled areas that appeared to be in the process of linking up with the main spalled region in Area C of Figure 121 are shown in Figure 127. The surfaces of these small spalled areas appeared to be inclined at approximately the same angle as the facets, but the characteristic striations were not visible in these areas. This is believed to indicate that the mechanism of lateral propagation of the spalled region may not have been by the same mechanism that formed the facets. The facets were generally not well developed at the edges of the spalled region, as can be seen in Figure 125. The same condition can be seen to persist on the right of Figure 127, which is also from Area C. The facets appear to extend up to, and perhaps slightly under, the chip that is about to become separated, but they clearly do not extend to the edge of the spalled region in the upper portion. This again

suggests that two slightly different mechanisms are operating to cause the spalling. Therefore, formation of facets does not appear to be associated with lateral growth, but it does appear to be associated with an increase in the depth of the spalled region.

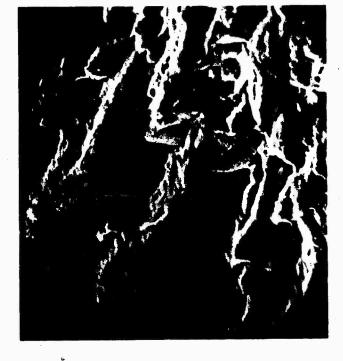
Figure 128. Enlarged Views of

Striations on the facets in Area C of Figure 121 are shown more clearly in Figure 128. As before, the appearance of the striae in this area is believed to indicate that the relative movement of the chips was downward toward the pitch line (to the left in Figure 128), and that the spalled region propagated from an undetermined origin near the pitch line. The area shown in Figure 128 left was rotated approximately 120° counterclockwise in Figure 128 right to obtain a better view of the sides of the facets. A small contamination particle is indicated by arrows in both figures to indicate the relative orientations of both figures. The facets were at an angle of approximately 45° to the surface of the gear tooth. The absence of striations on the vertical faces of the facets can be seen on the right, and these faces have a somewhat crystal-This suggests that the separation of chips line appearance. was by formation of a small flat chip by propagation of a subsurface crack that then fractured away from the parent material by the formation of secondary cracks between the subsurface crack and the surface of the gear tooth. Although this mechanism is obviously a fracture process, the appearance of the resulting surfaces does not correspond with any of the common fracture morphologies, and the mode of fracture cannot be It appears to be unique to rolling-sliding identified. fatigue fractures. The tip of the gear teeth showed considerable evidence of abrasion. This abrasion can be seen in Area D of Figure 121 and is shown at higher magnification in Figure 129. Extensive cracks can also be seen in this area. cracks were nearly parallel to the tip of the gear tooth; this suggests that the tensile component induced by the dragging force was a significant factor in the formation of these cracks.
